# **Demonstration Project: Protection and Enhancement of Delta In-Channel Islands**

**June 2006**

**CALFED Project # 2001-E200 and Amendment Contract # 01-N13-ERP Phase II**

## **FINAL MONITORING REPORT**

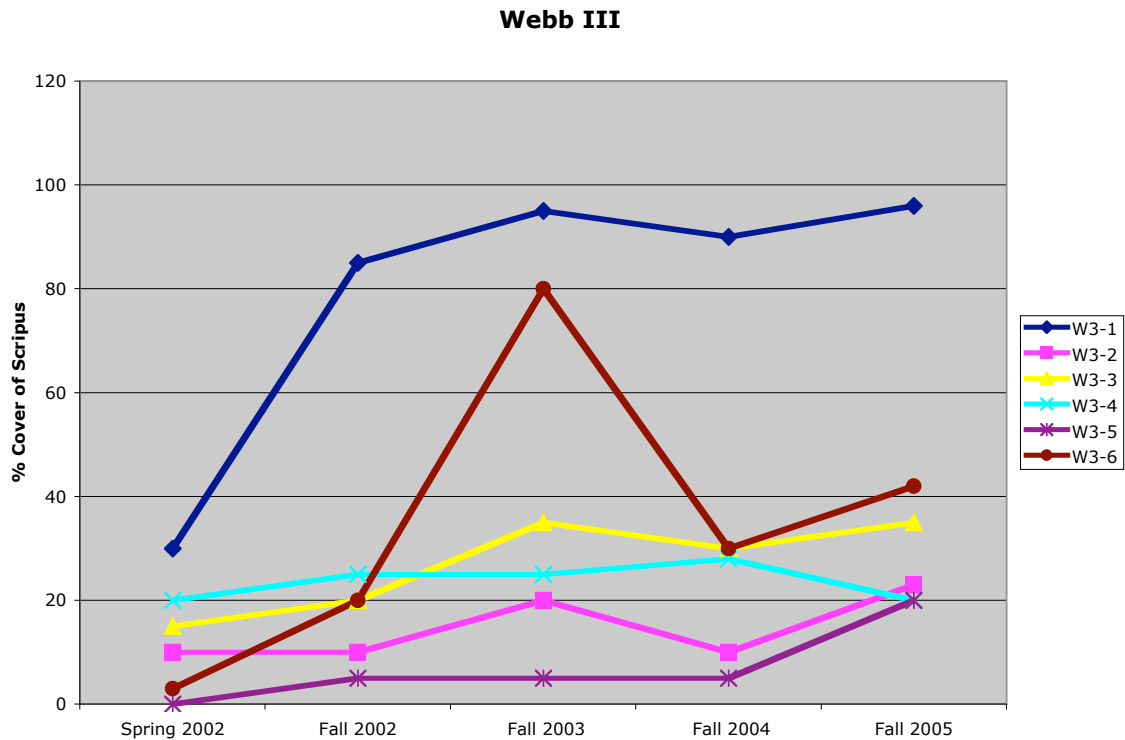
**Figure 5.** Percent area occupied by tules behind the monitoring units on Webb Tract III. The data is comparing spring 2002 monitoring to fall 2005 monitoring.

**Scirpus Cover.** Tule coverage was estimated including both endemic common tule (*Scirpus acutus* var. *occidentalis*) and the planted California bulrush (*Scirpus californicus*) (See Figure 5 and Tables VII and VIII). The cover of tules behind the monitoring units increased within all monitoring units when the 2002 data is compared to the results of monitoring in 2005. The change in tule cover as shown in Table XV ranges from no detectable difference (note that there was no loss indicating that the structure stabilized the site) to a 66 % increase over the duration of the monitoring. This demonstrates the effectiveness of the biotechnical structures in supporting the establishment, recruitment and or expansion of existing tules when given wave and erosion protection. The relevance of this is enhanced by the recognition of the role that tules play as ecosystem engineers in this environment.

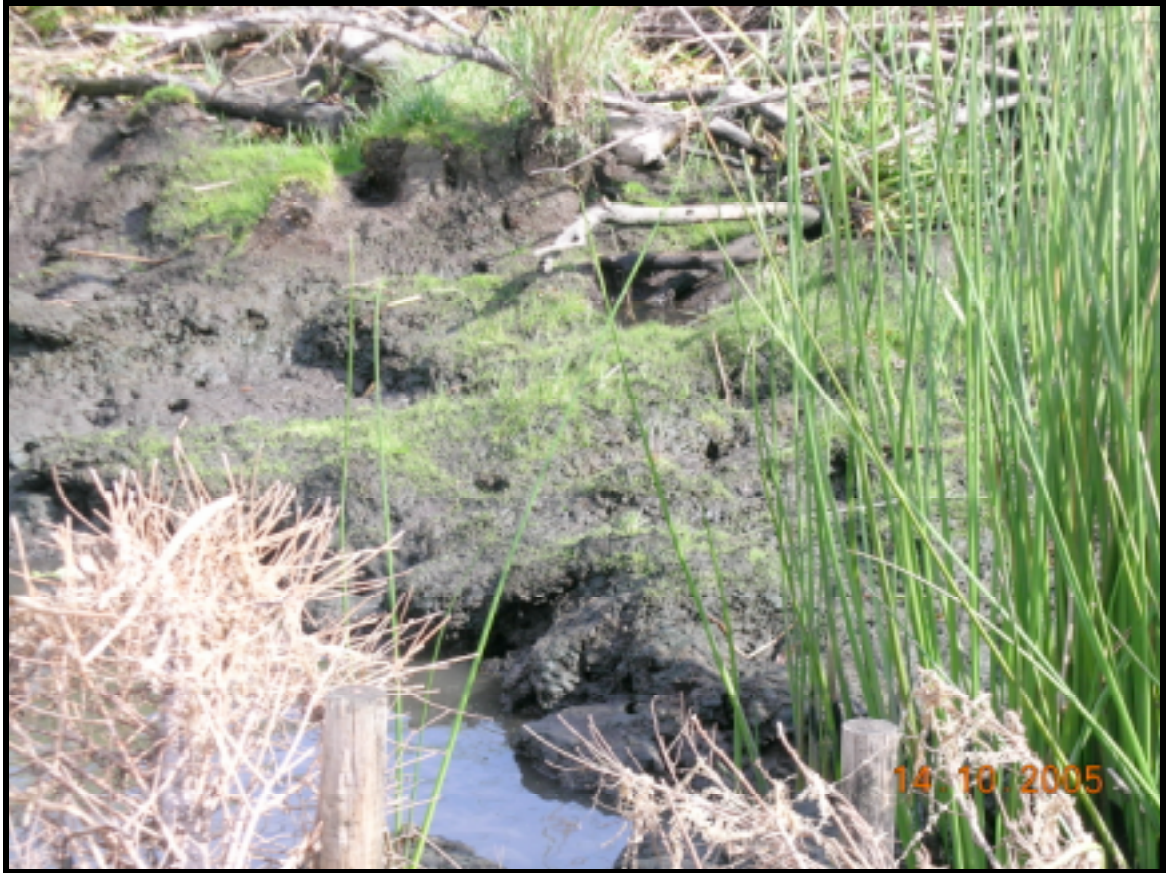
**Figure 6.** Mason's Lilaeopsis (*Lilaeopsis masonii*) growing behind brush wall on Webb III.

Mason's lilaeopsis (*Lilaeopsis masonii*) occurs in sun-exposed intertidal areas within monitoring units. Percent cover was assessed as shown in Table VII below. Significant increases were observed as shown in Table VII. In addition, we observed colonization of Mason's lilaeopsis (*Lilaeopsis masonii*) on several Large Anchored Rootwads in the intertidal zone.

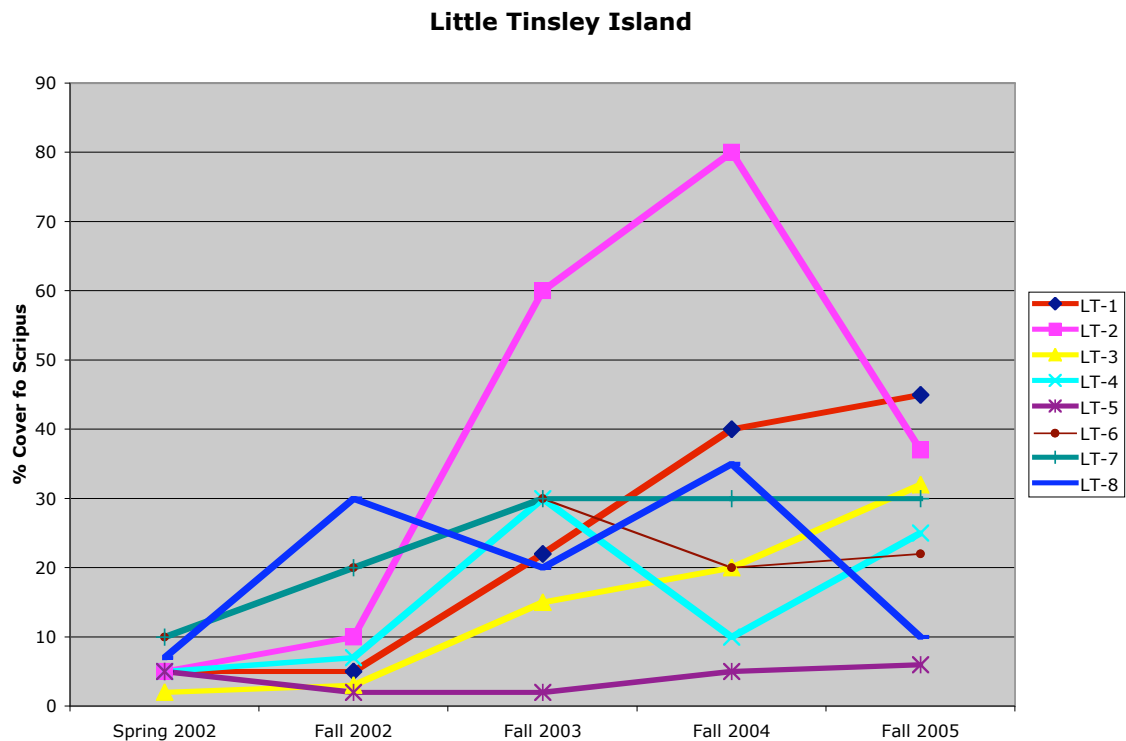
**Figure 7.** Percent area occupied by Tules behind the monitoring units on Little Tinsley Island. The data is comparing spring 2002 monitoring to fall 2005 monitoring.

Figure 7 and Tables VII and VIII). Tule or California bulrush percent coverage increased within all monitoring units. The increase of cover ranged from 1% to 40% increase in tule cover over the duration of the project as shown in Table XV.
